IHI COLD FORMED ALUMINUM SCREWS – COLD FLOW “SHALLOW FOLDS”

Insights to cold formed aluminum socket set screws and process artifacts.

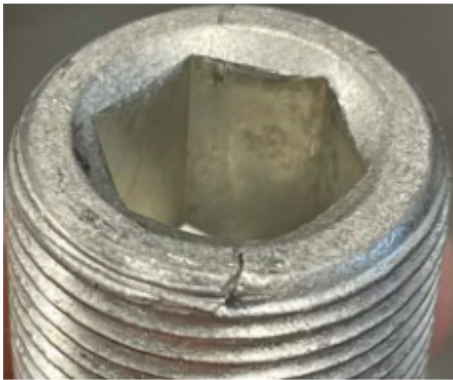
Fig 1

1. Cold formed aluminum screws are upset extruded like an aluminum pop can. The wall of the hex socket is created by material from the center (bottom of hex socket) being extruded up the sides to form the wall of the hex socket.

The flow of material upward forms up the top perimeter of the hex socket. That material does not all arrive at the same time so at some point, material moves laterally to fill the remaining empty space.

This commonly creates a shallow radial fold in the material, usually near (but significantly not at) the location of a hexagon apex point, whichever is the last to “fill” at the tightest spot.

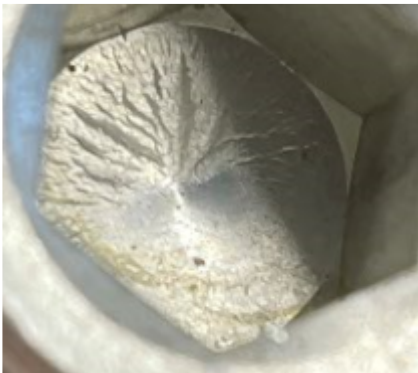
Fig 2

2. Other process related cold radial flow striations are to be seen at the bottom of the hex socket recess, where aluminum was moved outward to the periphery before its journey to the form the wall of the hex socket.

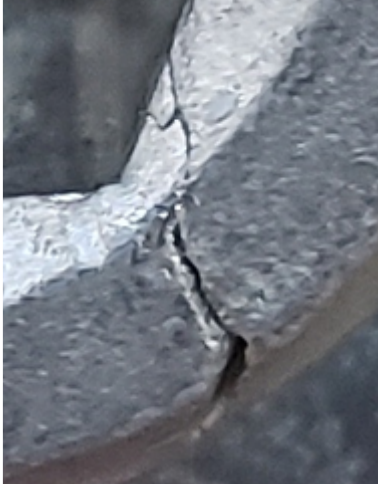
Fig 3

3. When the secondary operation of thread rolling occurs, also a cold forming operation, the hidden fold can open up a little or extend a little, becoming more prominent and sometimes can look more like a stress crack due to the localized temporary strain from thread forming. It is not caused by the hex bit torque and resulting bursting type hoop stress.

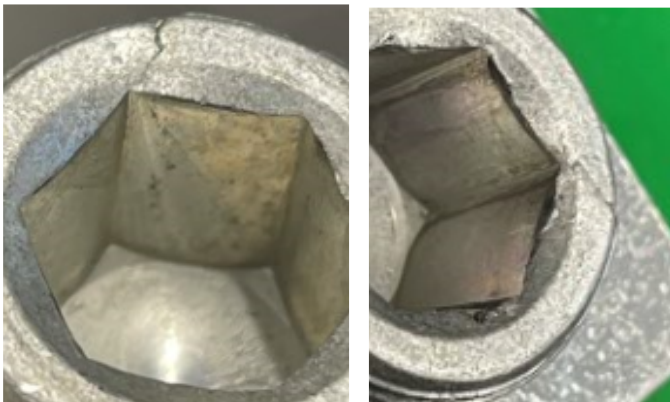
Fig 4

4. The shallow folds on the recess top surface are normal and do not in any way detract from the target engineered strength requirements of the hex socket in use.

Since this temporary thread rolling stress is local to the shallow fold and at the same shallow depths there is no subsequent propagation down the wall even under torque numbers way in excess of the user torque.

The depth of the fold is in the non-active portion of the hex socket since the hex socket is heavily countersunk, so the material above it is not in direct contact with the hex key.

There is more than adequate hoop strength in the main body of the hex even if the chamfer portions were machined away.

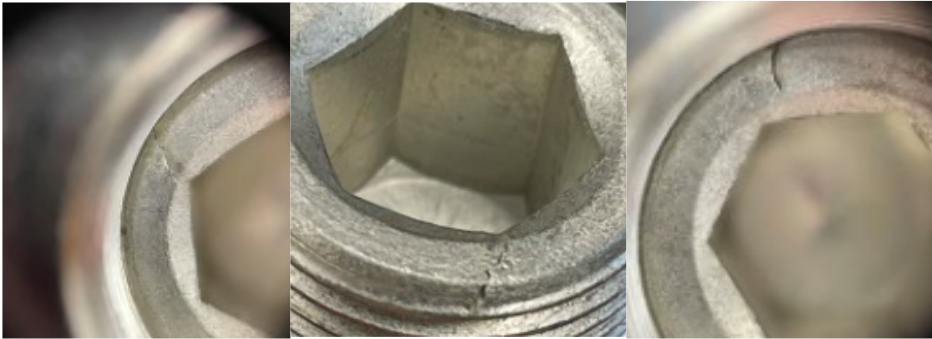
Fig 5

5. High percentages of visible folds are commonly seen and even when not visible (very tight folds) or barely visible, they are still there, on many if not most screws of this type.

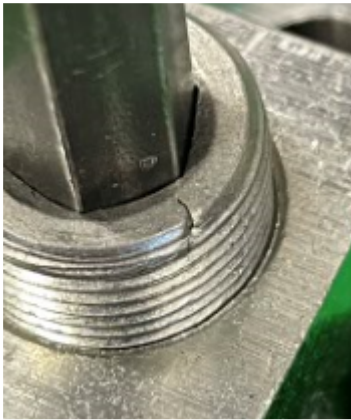
Fig 6

6. Testing on screws (11939 screws in this case) which had prominent shallow folds visible tested in worst case conditions:

100% of the hex socket depth outside the lug body thread, so no support of the recess walls is provided.

7. Even at an arbitrary +60% over user torque of 375 in-lbs (600 in-lb) no signs of failure or any crack propagation was seen on “worst case” samples pulled from stock.

600 in-lb test user torque is 375 in-lbs 11939 screw 1/2” hex socket
