IHI Connectors International Hydraulics Inc copyright 2010

ACCELERATED RELIABILITY TESTING -- ProStar and SunSaver Controllers: July 1997 --

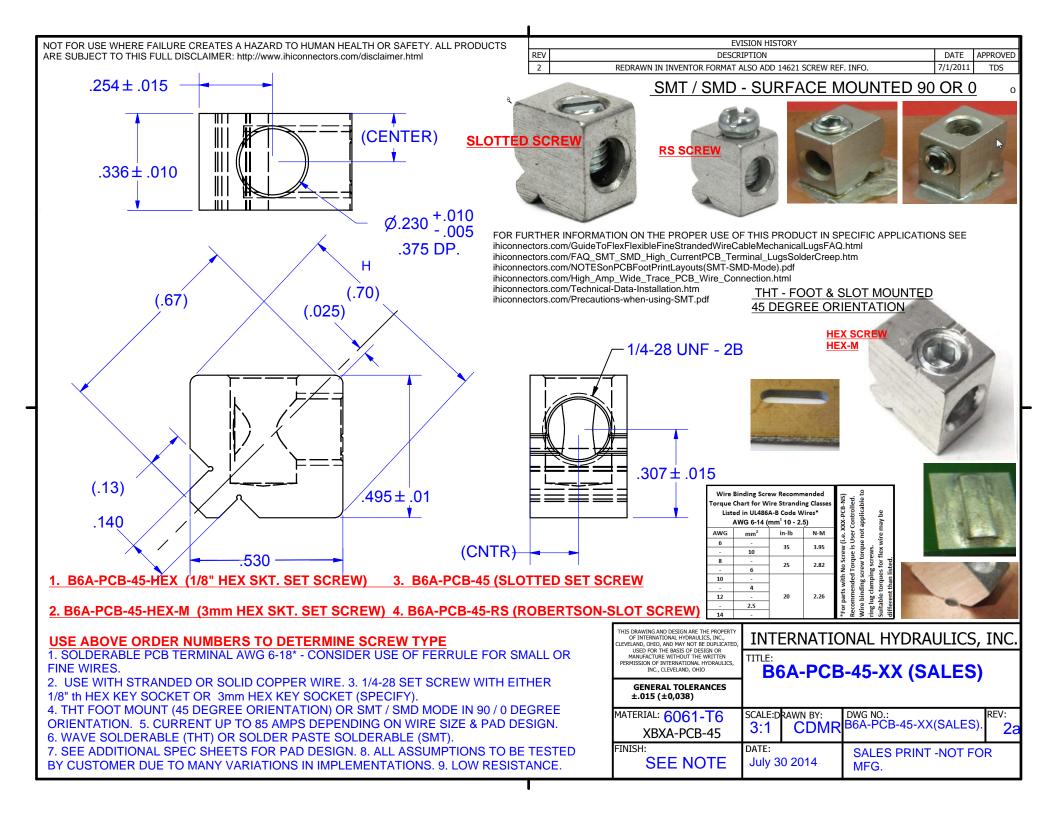
PAGE 1 DF 3. RECOMMENDED PCB THICKNESS .06"-.093". PLATED VIAS. DOUBLE SIDED. DO TORQUE TEST TO ENSURE YOUR SELECTED UL WIRE SIZE SCREW TORQUE REQUIRMENTS & PULL OUTS ARE MET FOR ON BOARD TESTING. AVOID SLOTS TOO NEAR TO BOARD EDGE. SUITABLE FOR WAVE SOLDER WITH SAC SOLDER. PREFLUX AND PREHEAT. SEE TYPICAL WAVE SOLDER PROFILE. AS TOO MANY VARIABLES ARE IN PLAY WITH TYPE OF BOARD AND TEMPERATURE RISE CHOSEN BY DESIGNER ALL DESIGN ASPECTS NEED TO BE TESTED FOR EACH APPLICATION BY USER.
