SMT / SMD - SURFACE MOUNTED 90 OR 0

**THT - FOOT & SLOT MOUNTED
45 DEGREE ORIENTATION**

TITLE:
B6A-PCB-45-XX (SALES)

DWG NO.: **B6A-PCB-45-XX(SALES)**

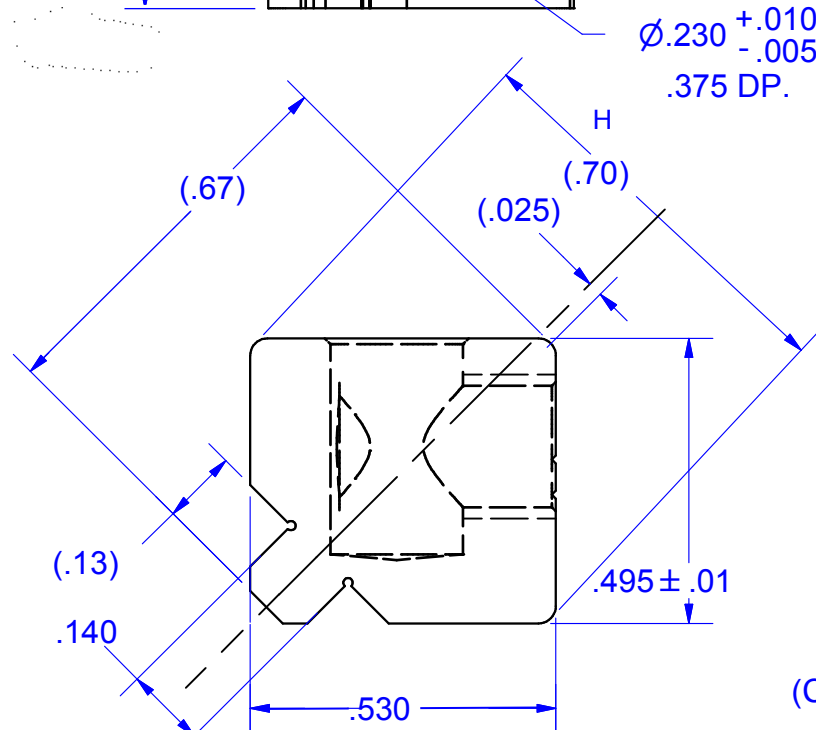
- 1. B6A-PCB-45-HEX (1/8" HEX SKT. SET SCREW)
- 2. B6A-PCB-45-HEX-M (3mm HEX SKT. SET SCREW)
- 3. B6A-PCB-45 (SLOTTED SET SCREW)
- 4. B6A-PCB-45-RS (ROBERTSON-SLOT SCREW)

1. SOLDERABLE PCB TERMINAL AWG 6-18* - CONSIDER USE OF FERRULE FOR SMALL OR FINE WIRES.
2. USE WITH STRANDED OR SOLID COPPER WIRE.
3. 1/4-28 SET SCREW WITH EITHER 1/8" th HEX KEY SOCKET OR 3mm HEX KEY SOCKET (SPECIFY).
4. THT FOOT MOUNT (45 DEGREE ORIENTATION) OR SMT / SMD MODE IN 90 / 0 DEGREE ORIENTATION.
5. CURRENT UP TO 85 AMPS DEPENDING ON WIRE SIZE & PAD DESIGN.
6. WAVE SOLDERABLE (THT) OR SOLDER PASTE SOLDERABLE (SMT).
7. SEE ADDITIONAL SPEC SHEETS FOR PAD DESIGN.
8. ALL ASSUMPTIONS TO BE TESTED BY CUSTOMER DUE TO MANY VARIATIONS IN IMPLEMENTATIONS.
9. LOW RESISTANCE.

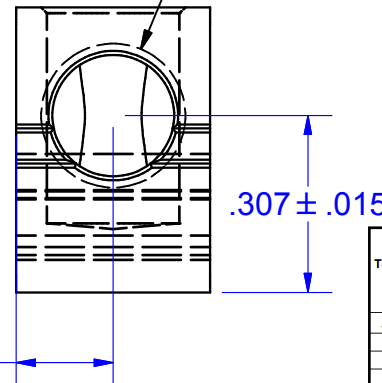
**HEX SCREW
HEX-M**

Ø.230 +.010
-.005
.375 DP.

1/4-28 UNF - 2B

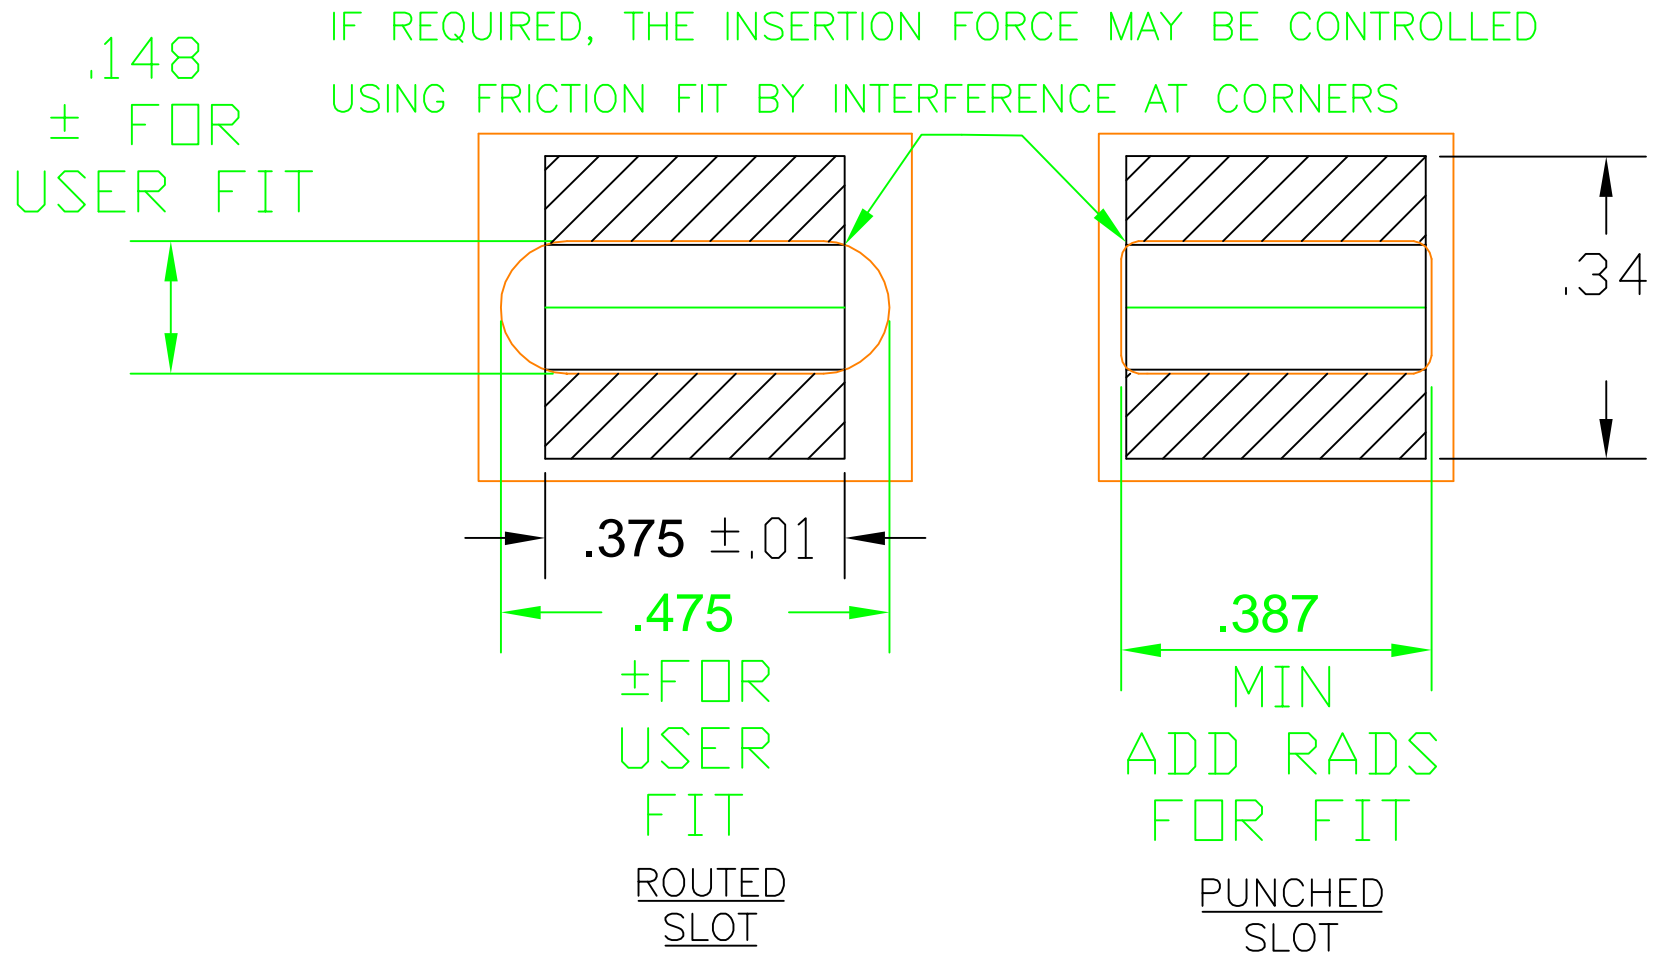
SOLDER FOOT PRINT FOR IHI B4A-PCB-45-XX

PAGE 1 OF 3. RECOMMENDED PCB THICKNESS .06"-.093". PLATED VIAS, DOUBLE SIDED. DO TORQUE TEST TO ENSURE YOUR SELECTED UL WIRE SIZE SCREW TORQUE REQUIREMENTS & PULL OUTS ARE MET FOR ON BOARD TESTING, AVOID SLOTS TOO NEAR TO BOARD EDGE. SUITABLE FOR WAVE SOLDER WITH SAC SOLDER, PREFLUX AND PREHEAT. SEE TYPICAL WAVE SOLDER PROFILE. AS TOO MANY VARIABLES ARE IN PLAY WITH TYPE OF BOARD AND TEMPERATURE RISE CHOSEN BY DESIGNER ALL DESIGN ASPECTS NEED TO BE TESTED FOR EACH APPLICATION BY USER.
